Issue 1/2002

# **Spiral During Flight Training**

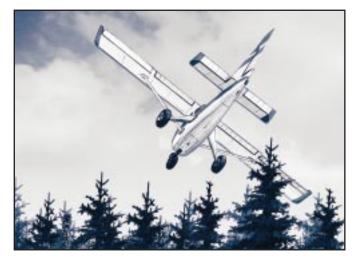
On April 6, 1999, an instructor and student departed in a Cessna 152 on a one-hour training flight to practise climbing, descending, and turning exercises. Near the end of the flight, a witness to the accident heard an aircraft flying overhead, then the engine noise stopped. This caused the witness to look in the direction of the aircraft; it was in a nosedown attitude, and it rotated twice to the right before disappearing behind a treeline located within 1000 ft of the witness. The aircraft struck trees at high speed and crashed in a swamp. The witness estimated that the aircraft was well below 2000 ft above ground level (AGL) when first observed. The instructor and student received serious injuries and succumbed later to their injuries. This synopsis is based on the Transportation Safety Board of Canada (TSB) Final Report A9900079.

Visual meteorological conditions prevailed at the time of the occurrence. The aircraft was certified, equipped, and maintained in accordance with the existing regulations. The engine was disassembled and no discrepancies were noted that would have precluded normal engine operation prior to the accident. The wreckage was first examined at the crash site, then removed to a salvage facility and reexamined. None of the damage was identified as preimpact. Examination revealed that the aircraft's rate of descent was shallow and that the wings were level at impact. The flaps were in the up position. There was no indication of pre-impact structural failure and, because of the severe impact damage and fragmentation of the airframe, it could not be determined if a flight control malfunction had occurred. The airspeed indicator (ASI) was forwarded to the TSB Engineering Branch for examination. Examination of the ASI did not provide any information with respect to airspeed indication at the time of impact. There was no pre- or post-crash fire.

especially, continue below 2000 ft AGL. The TSB could not determine why a spiral was continued to an altitude from which a safe recovery could not be performed. The wing impact damage indicated that the aircraft was probably entering a recovery attitude prior to striking the trees. The sudden absence of engine noise that captured the witness's attention likely resulted from the pilot initiating the spiral recovery procedure. It was evident that the engine was capable of producing power. The TSB could not determine why the aircraft entered a spiral manoeuvre.
